Gorse, CA and Glew, D and Johnston, D and Fylan, F and Miles-Shenton, D and Smith, M and Brooke-Peat, M and Farmer, D and Stafford, A and Fletcher, M and Thomas, F (2017) Core cities Green Deal monitoring project – Leeds. Project Report. Department of Energy and Climate Change.

# Core cities Green Deal monitoring project

Prepared for the Department of Energy and Climate Change

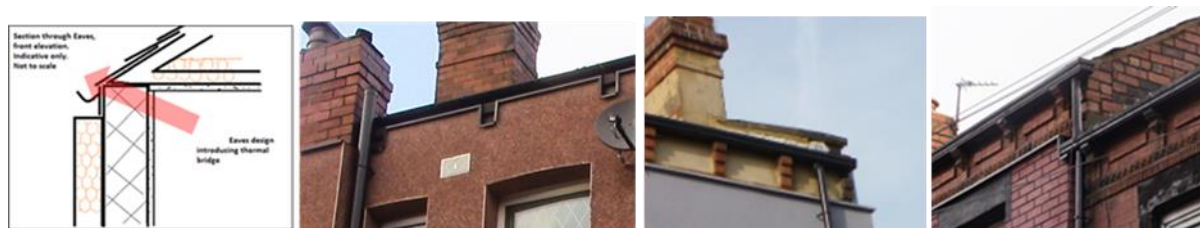
Figure 2-1 Thermal breaks introduced to top floor wall/ceiling junctions: pre-1919 terraces and back-to-backs

In terraces, adjacent properties are sometimes built at different levels so that roof lines are not continuous and party walls become external walls. Where adjacent properties were in the same ownership and both properties had EWI applied, it was found that this part gable external wall was insulated with EWI. Where adjacent properties were not in the same ownership, and were not both insulated, this wall was not insulated as seen in Figure 2-1. If this wall encloses a conditioned space internally, e.g. an attic room, which does not have IWI applied internally, it forms a thermal bridge.

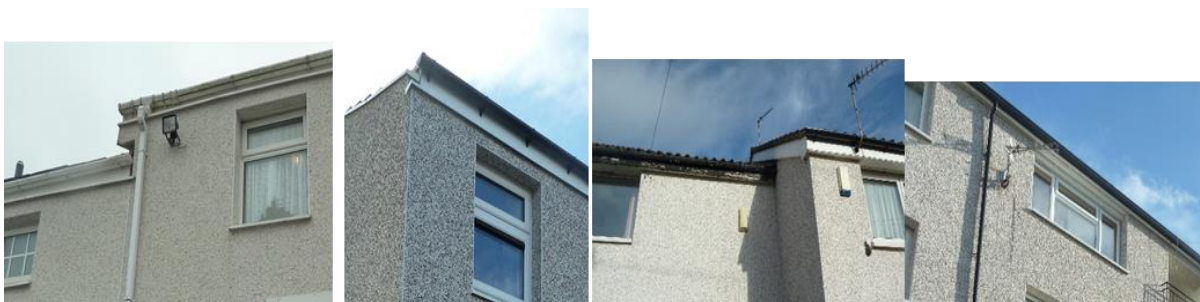
*Figure 2-3 Thermal breaks introduced to top floor wall/ceiling junctions: 1945-1970s system built, including flats, terraces and semis. The roof, eaves and sometimes rainwater goods are not amended for the addition of EWI*

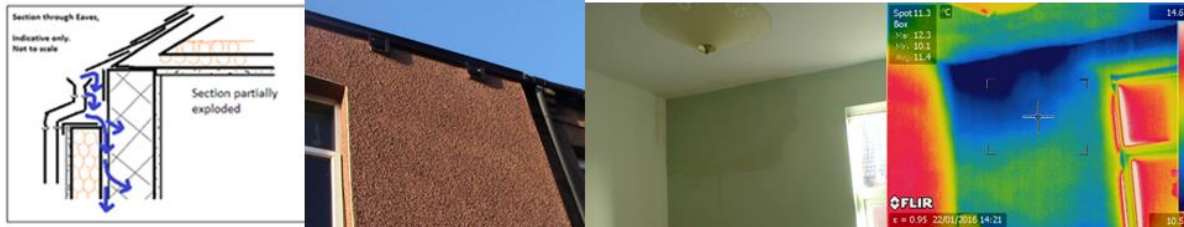
*Figure 2-5 Effects of water ingress through an imperfect seal at the top of EWI*

It is not unusual for rainwater goods to leak if the fixings become dislodged or blocked for any reason such as wind, build-up of debris/leaves, or even short term issues such as snow. For EWI, if seals between the top capping and the wall is ineffective, water ingress is able to seep between the insulation and original wall. See Figure 2-5 for an indication of the effect of this. The photographs show the rear to one pre-1919 terraced property where there was a leak at the gutter post-intervention and the first floor bedroom wall subsequently suffered from dampness. The flashing at eaves was repaired but the wall was continuing to dry out internally

as the new EWI and render did not permit external drying out. As a rule of thumb, drying out typically takes one month per 25mm wall thickness.

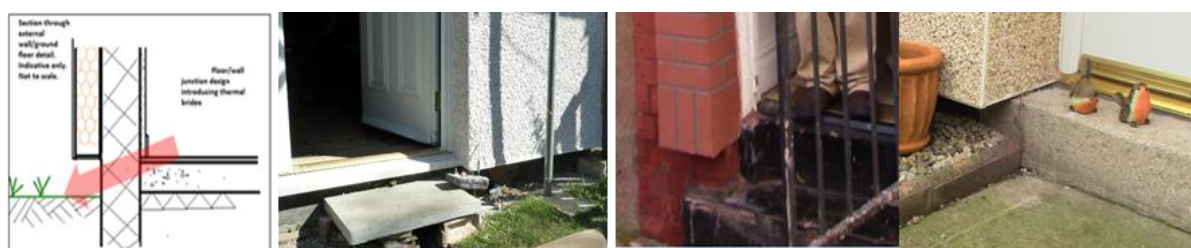
Figure 2-8 Thermal breaks introduced to ground floor/wall junctions where the EWI is stopped around 150mm above ground level. The examples show a 1970 terrace, a pre-1919 terrace and a 1950s semi

There is a requirement under Building Regulation C2 that the walls shall adequately protect the building and the people from the harmful effects of ground moisture and precipitation. A standard way of achieving this is to ensure that applied surfaces to walls, including render and insulation which have the capacity to wick up moisture, are a minimum of 150mm above ground level and do not result in a bridge across a damp proof course (dpc). Dpcs themselves are usually placed at 150mm above ground level. For many properties, the finished internal floor level is at dpc level. This essentially means that there should be a break in externally applied insulation at this point. Some schemes provide for this break incorporating the equivalent of a dpc and then insulation which will not result in rising damp, or moisture penetrating internally, or else bridging of the dpc is applied below the house wall dpc level to ensure continuity of the thermal envelope. Most schemes however do not do this, resulting in a thermal break. See Figure 2-8.

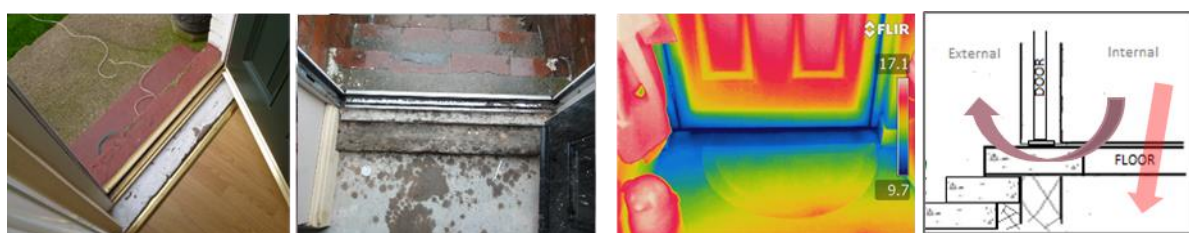
*Figure 2-10 Thermal breaks due to lack of insulation to ground floor and single slab door thresholds. These thresholds are found at suspended timber or solid concrete ground level floors*

Where a lack of floor insulation is coupled with a thermal break at ground floor/wall junction as described above, the issue might be exacerbated.

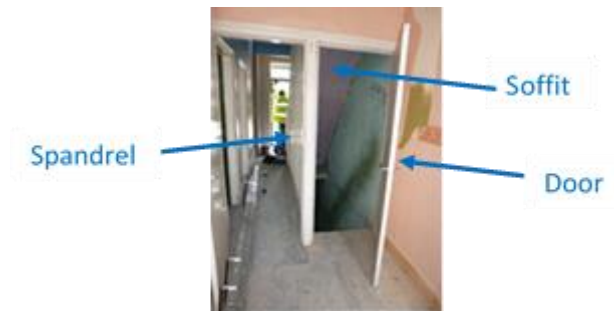
Figure 2-11 Interfaces between the unheated basement and heated ground floor which need to be insulated

These doors, spandrels and soffits form the interface between the unheated, uninsulated basement and the heated, insulated ground floor areas. Without the provision of insulation to these, there is a large thermal bridge between the unheated basement and the ground floor living area.

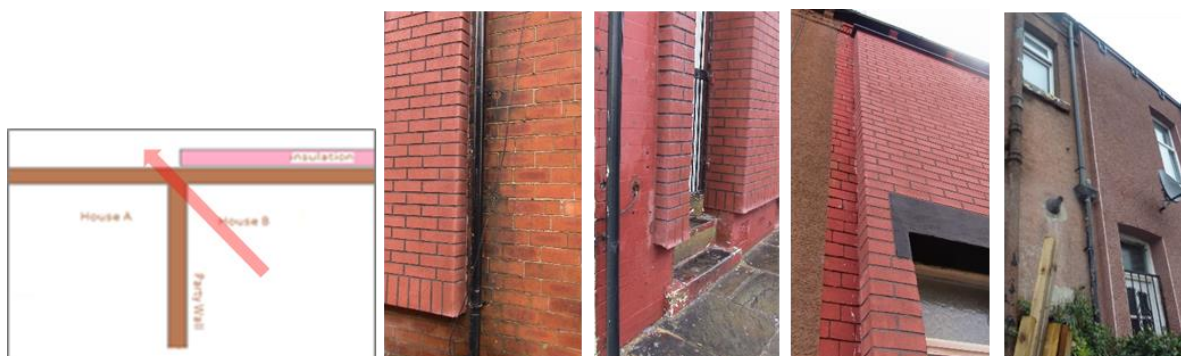
*Figure 2-12 Thermal break at party wall/external wall junctions between differently owned terraced properties*

For EWI, adjacent properties may not be in the same ownership. The external wall insulation cannot therefore be applied onto the neighbouring property without incurring trespass, party wall issues, etc. To avoid conflicts arising the EWI needs to be kept away from the centre-line of the party wall. This generally results in a thermal break at this area, see Figure 2-12.

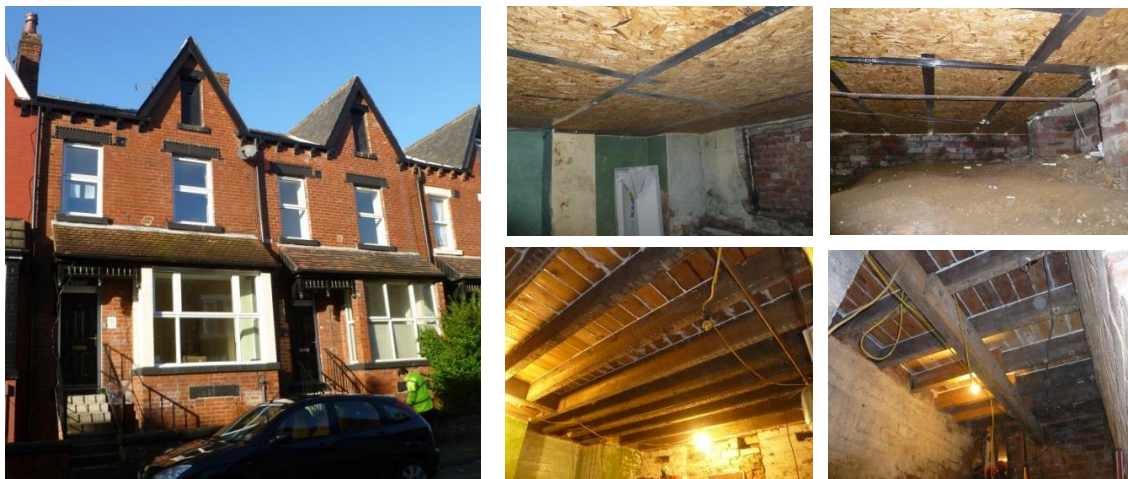
*Figure 3-3 Dwellings I-02 & I-03, and the different treatment of the suspended timber ground floor, views from the cellar; top – contractor retrofit, bottom – local housing charity retrofit prior to insulation installation*

2 dwellings varied considerably. The sub-contractors refurbishing I-02 were highly conscious of time and labour costs, so utilised solutions which minimised these; for the local housing charity refurbishing I-03 the main concern was material costs and developed alternative solutions accordingly. Figure 3-3 illustrates these alternative approaches to the same detail, the suspended timber ground floor above the cellar. The contractors fitted insulation to the floor and a new airtight cellar ceiling, the local housing charity removed the existing cellar ceiling and sealed around the floorboards and joists before installing the floor insulation. The result was that the local housing charity virtually eliminated infiltration through the ground floor and attained a final air permeability result below  $5 \text{ m}^3/(\text{h.m}^2) @ 50\text{Pa}$ , the sub-contractor retrofit left infiltration paths through ground floor around the joists into the “solid” walls and an air permeability of over  $12 \text{ m}^3/(\text{h.m}^2) @ 50\text{Pa}$ .

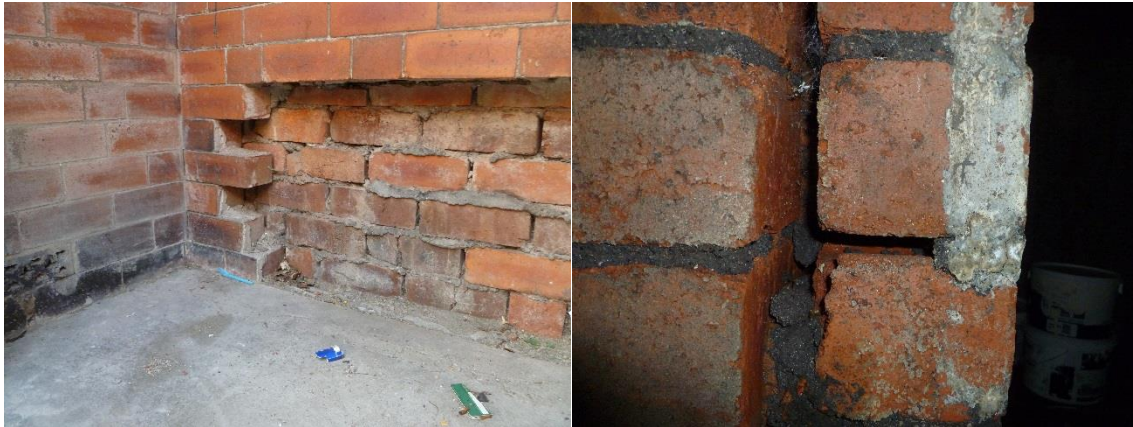
*Figure 3-5 The difference in quality of brickwork between inner and outer leaf of a solid wall and the finger cavity between the them*

In a number of solid-walled dwellings investigated the internal wet-plaster finish was removed due to its poor condition, and a new internal wall lining of either plasterboard or insulated plasterboard was applied using dabs of adhesive to fix the new boards to the un-finished masonry wall. Figure 3-5 shows how the “inner leaf” of a solid wall can allow air exchange between the “finger cavity” of the solid wall and the dwelling interior through unfilled perpend and bedding layers between the bricks. The old internal plaster finish provided an effective air barrier, removing this (as in Figure 3-6) creates additional air leakage paths that were not present prior to refurbishment. Figure 3-7 illustrates these new post-retrofit air leakage paths, with air entering from the solid wall finger-cavity through gaps in the inner leaf and travelling around the plasterboard adhesive dabs behind the plasterboard on the internal wall.

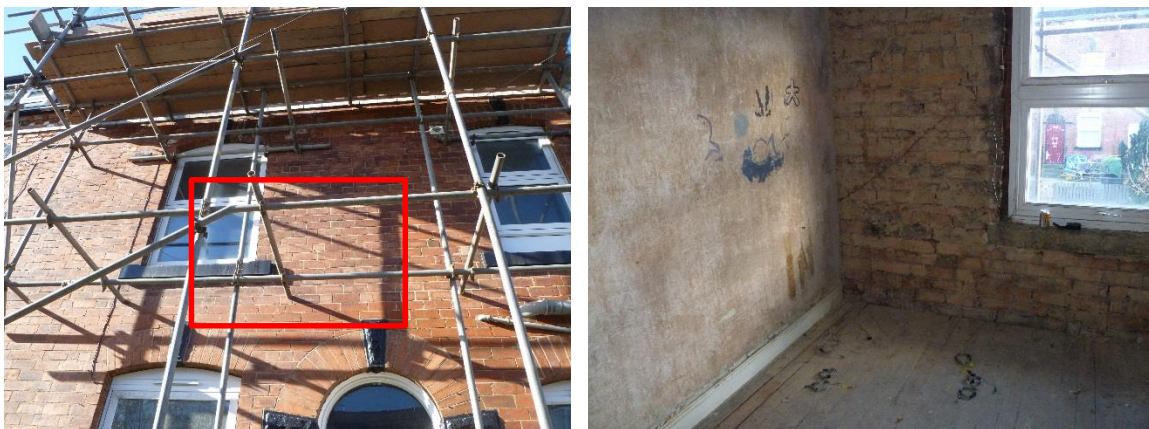
*Figure 3-6 Dwelling C-02 prior to application of IWI insulated plasterboard on the external wall and plasterboard on the internal wall.*

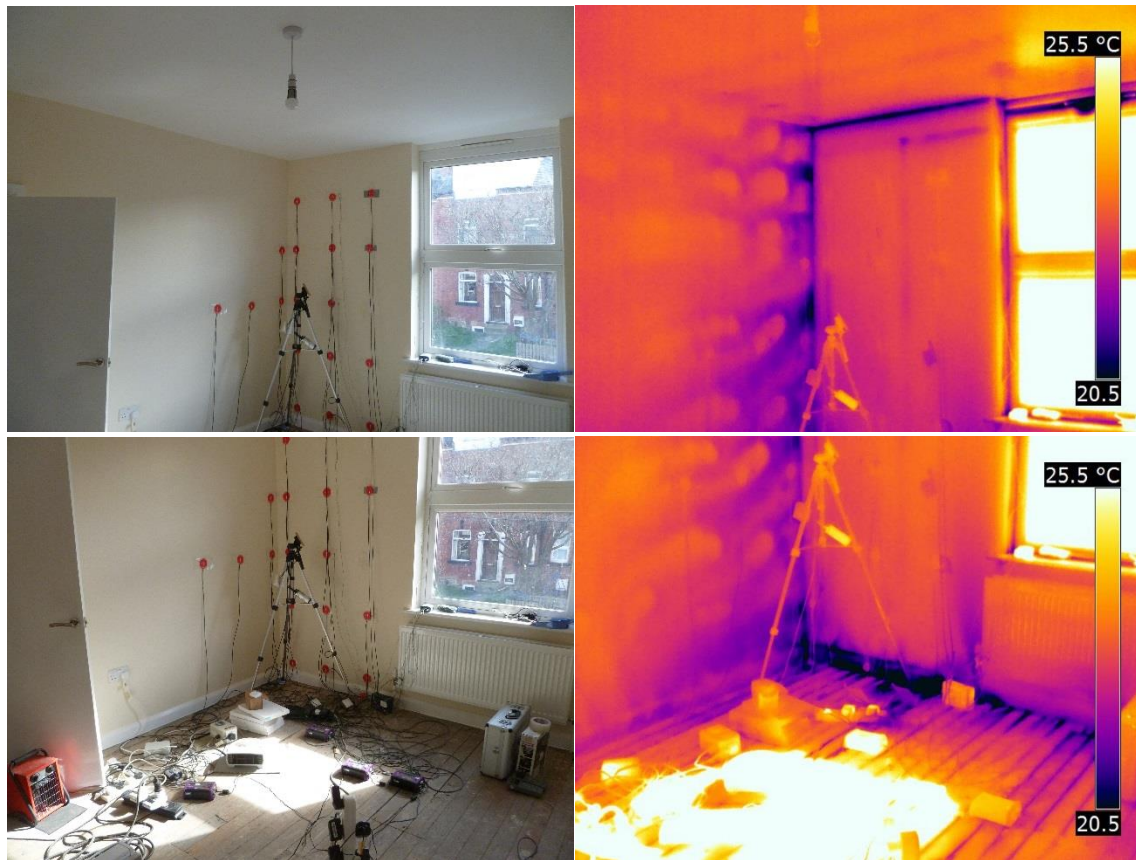
*Figure 3-7 Dwelling C-02 under depressurisation following refurbishment.*

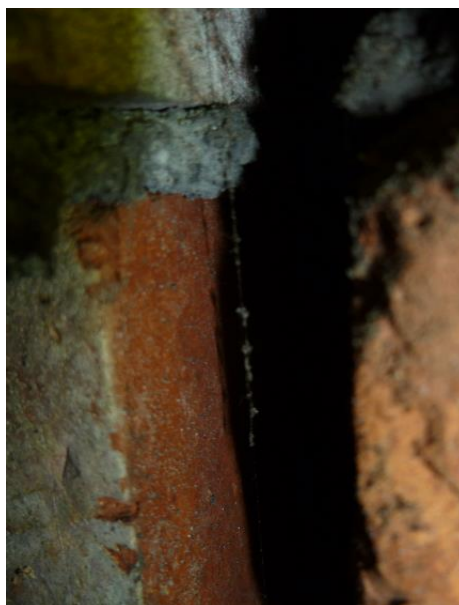
*Figure 5-3 Cavity in Solid Brickwork External Wall*

Inspections of the solid brickwork external walls at the properties under assessment have revealed that the volume between the two masonry leaves tied together with headers is not completely filled with mortar. The cavity shown in Figure 5-3 is largely composed of air with a fraction of brick headers and mortar. Thermal modelling was undertaken to assess the effect of a notional air cavity on the  $\Psi$ -value and  $f_{Rsi}$  of each junction design. An equivalent thermal conductivity ( $\lambda_{eq}$ ) was calculated for the air cavities. The heat flow in the cavities in the ground floor, party wall and partition junctions was deemed to be predominately horizontal permitting a single  $\lambda_{eq}$  to be calculated for the air cavity layer in these thermal models. Based on the bonding of the masonry shown in Figure 5-4, a brick header fraction of 0.054 and an air fraction of 0.946 were calculated using measurements obtained on site. A  $\lambda_{eq}$  for the air layer was calculated as 0.105 W/m·K using Equation 3 by inputting a  $\lambda$  of 0.067 W/m·K for the air (BSI, 2007) and a  $\lambda$  of 0.770 for the brick headers (Anderson, 2006). The  $\lambda_{eq}$  of the mortar filled cavity layer was calculated as 0.931 W/m·K using the same fractions but the  $\lambda$  of air was exchanged for the  $\lambda$  of mortar. The quantity of mortar in the air cavity could not be determined and as a result in the calculation was simplified to exclude the effect of the mortar droppings.
